F1 (Fukushima Daiichi Nuclear Power Station) Issues

As of 5 September, 2013
Nuclear Regulation Authority (NRA), Japan

I. Current situation of contaminated water leakage

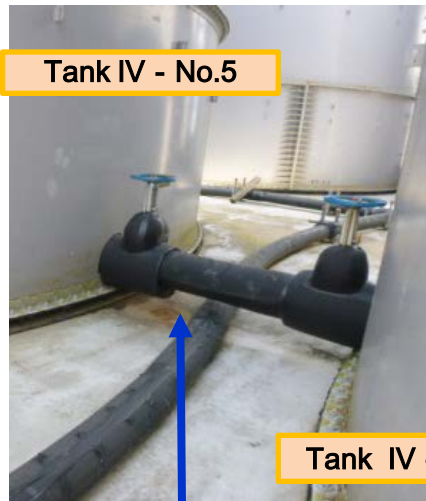
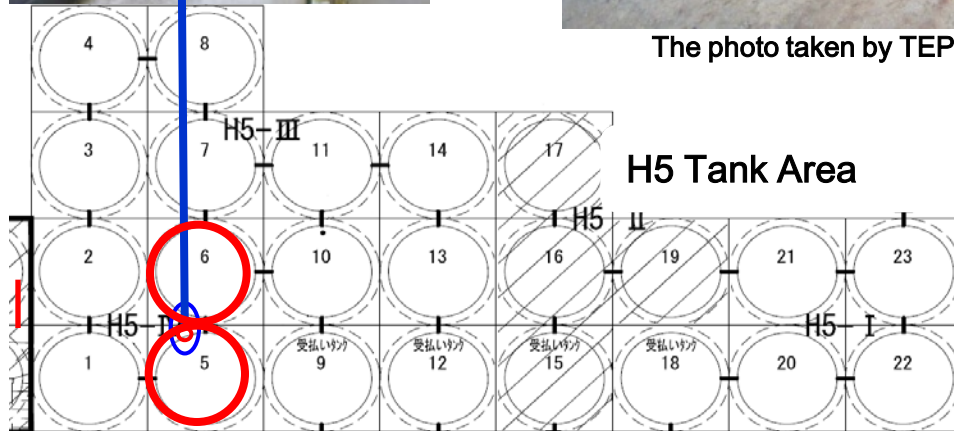
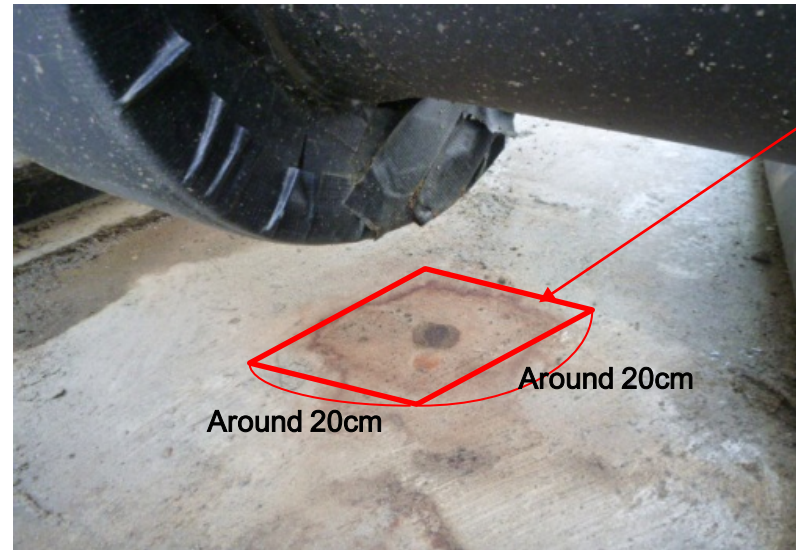
Water Leakage from Connection Pipe between Storage Tanks (H5 Tank Area)

The photo taken by TEPCO on 31 August

Puddle trace (20 cm x 20 cm)

At the point 5cm from the surface of the puddle trace 230 mSv/h * of β rays was detected by TEPCO on 31 August.

It was found by TEPCO that one drop of contaminated water fell every 90 seconds after the cover stuff of the flange was removed, and then this water drop has stopped by TEPCO's tightening up the bolts of flange on 1 September.

Radioactivity (Sampling date: 31 August 2013)

Nuclide	Concentration (Bq/cm ³)
Cs-134	25
Cs-137	61
Total Beta	3.0×10 ⁵

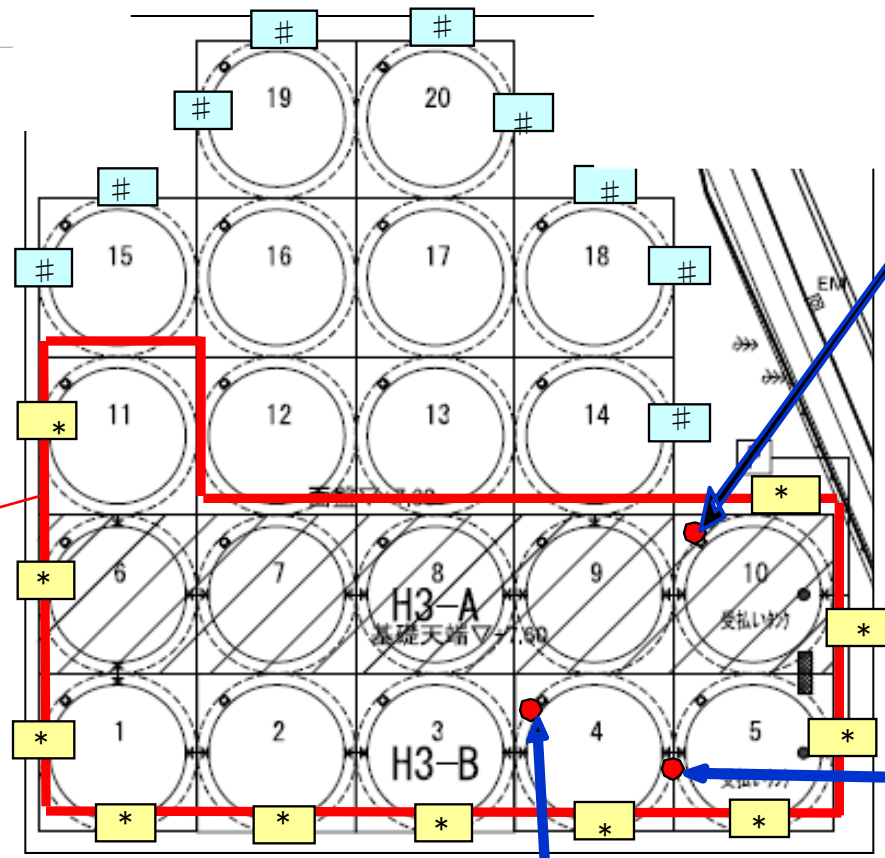
H3 Tank Area

Tank A-No.10

At the point 5cm from the flange, 220m Sv/h * of β rays was detected by TEPCO on 31 August. No water leakage was found around here.

Tank B-No.4(South)

At the point 5cm from the flange, 1800 mSv/h * of β rays was detected by TEPCO on 31 August. No water leakage was found here.

Tank B-No.4 (North)

At the point 5cm from the flange, 2200 mSv/h * of β rays was detected by TEPCO on 3 September. No water leakage was found around here.

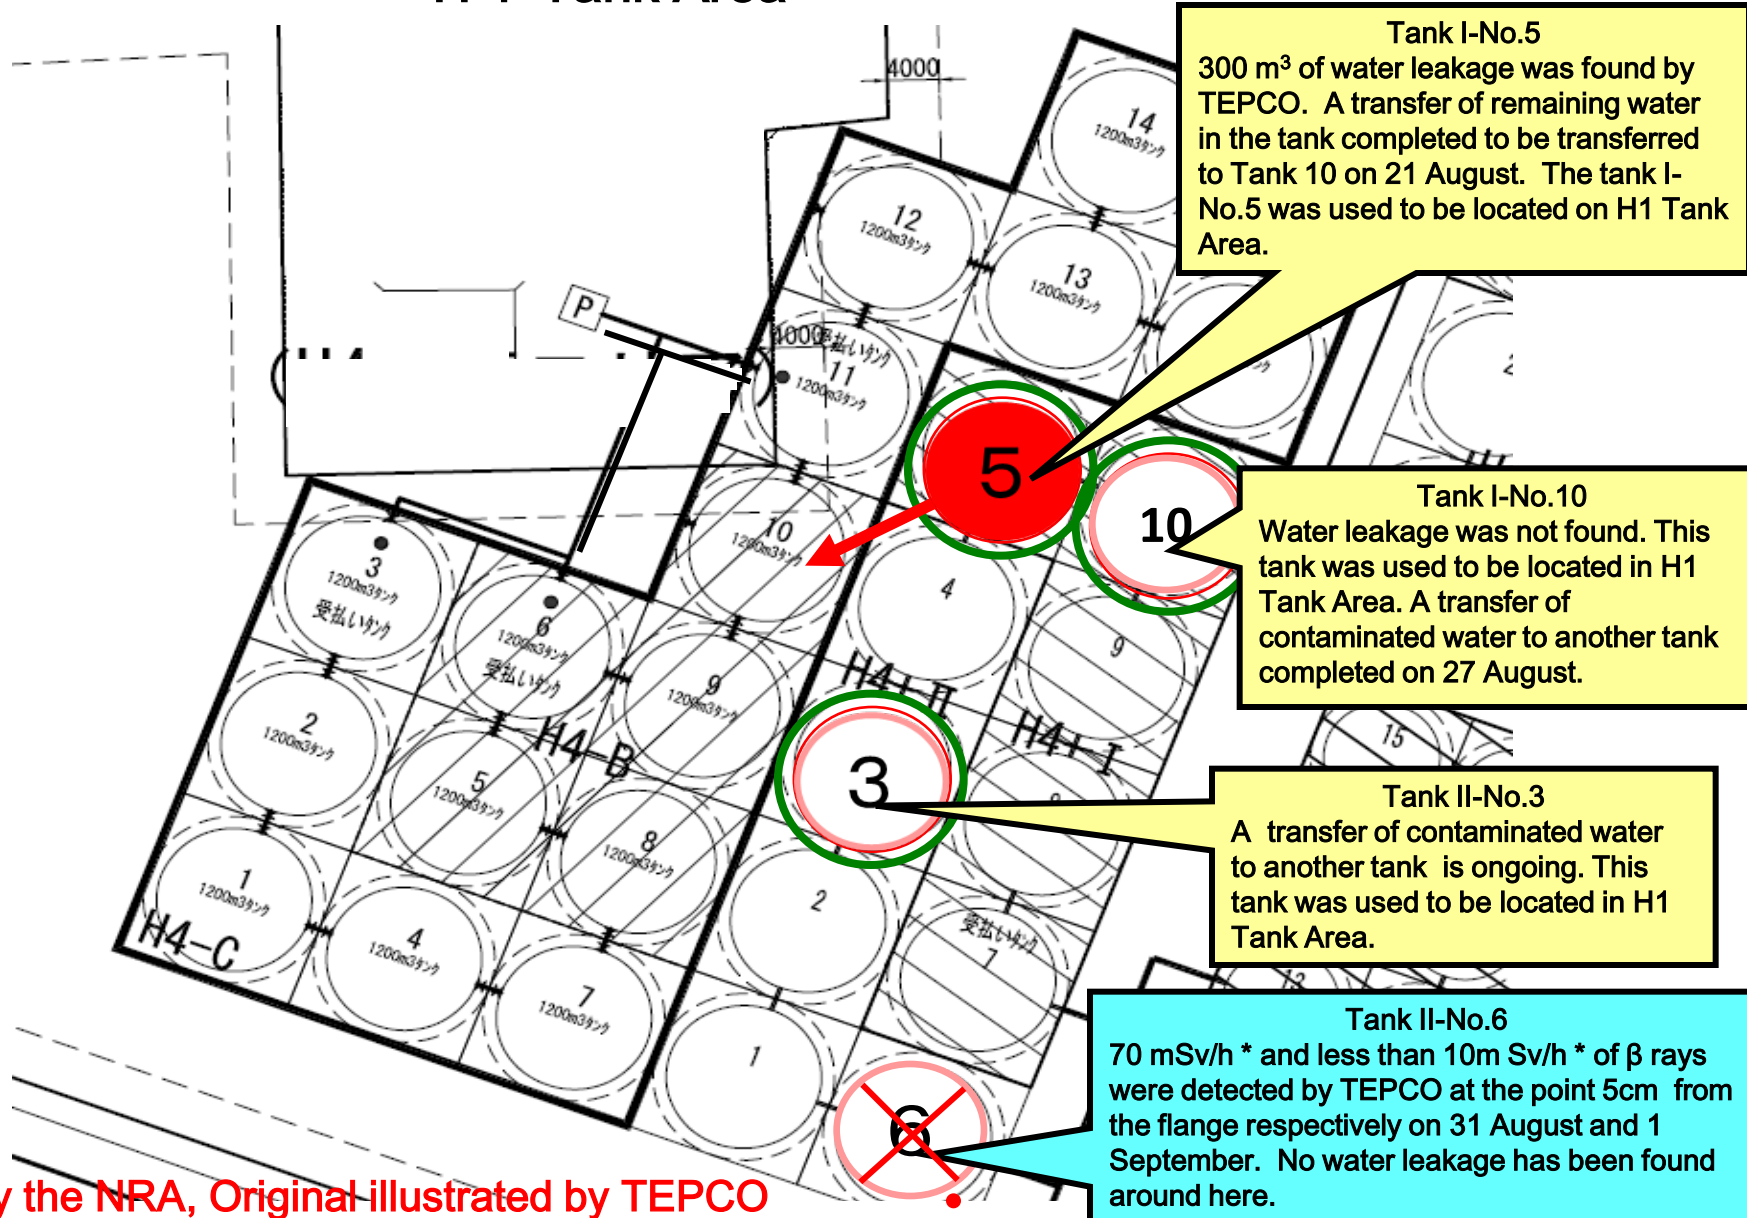
H 4 Tank Area

Tank I-No.5
300 m³ of water leakage was found by TEPCO. A transfer of remaining water in the tank completed to be transferred to Tank 10 on 21 August. The tank I-No.5 was used to be located on H1 Tank Area.

Tank I-No.10
Water leakage was not found. This tank was used to be located in H1 Tank Area. A transfer of contaminated water to another tank completed on 27 August.

Tank II-No.3
A transfer of contaminated water to another tank is ongoing. This tank was used to be located in H1 Tank Area.

Tank II-No.6
70 mSv/h * and less than 10m Sv/h * of β rays were detected by TEPCO at the point 5cm from the flange respectively on 31 August and 1 September. No water leakage has been found around here.
