F1 (Fukushima Daiichi Nuclear Power Station) Issues

As of 5 September, 2013
Nuclear Regulation Authority (NRA), Japan

I. Current situation of contaminated water leakage

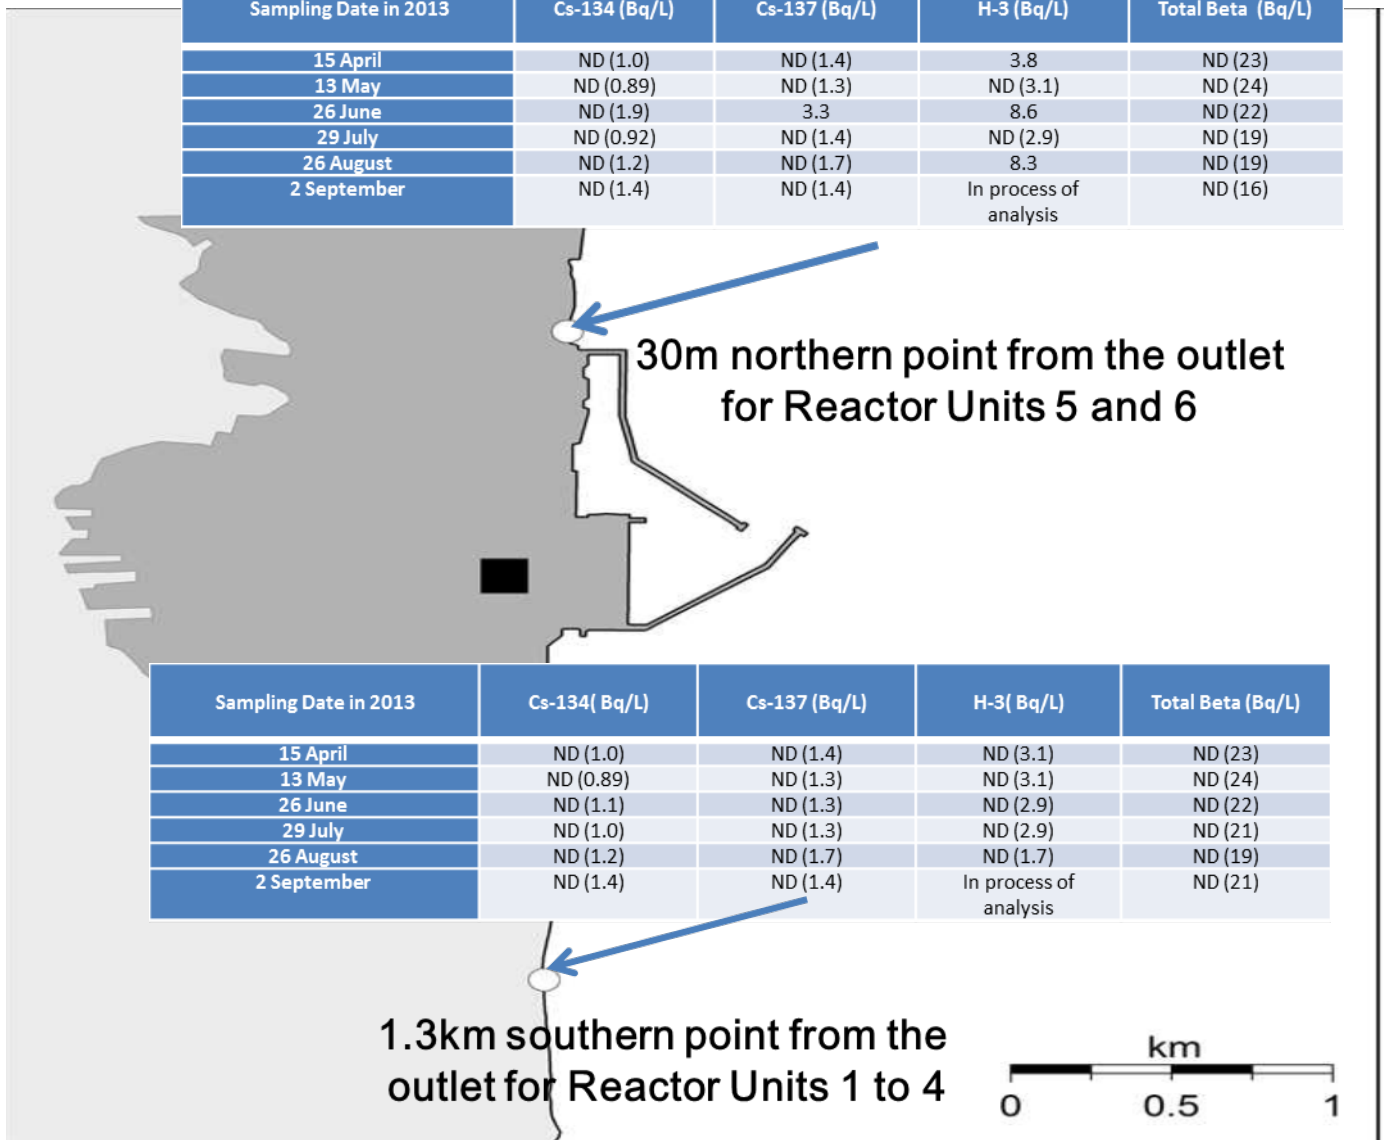
Current information on radioactivity in seawater

Sampling Date in 2013	Cs-134 (Bq/L)	Cs-137 (Bq/L)	H-3 (Bq/L)	Total Beta (Bq/L)
15 April	ND (1.0)	ND (1.4)	3.8	ND (23)
13 May	ND (0.89)	ND (1.3)	ND (3.1)	ND (24)
26 June	ND (1.9)	3.3	8.6	ND (22)
29 July	ND (0.92)	ND (1.4)	ND (2.9)	ND (19)
26 August	ND (1.2)	ND (1.7)	8.3	ND (19)
2 September	ND (1.4)	ND (1.4)	In process of analysis	ND (16)

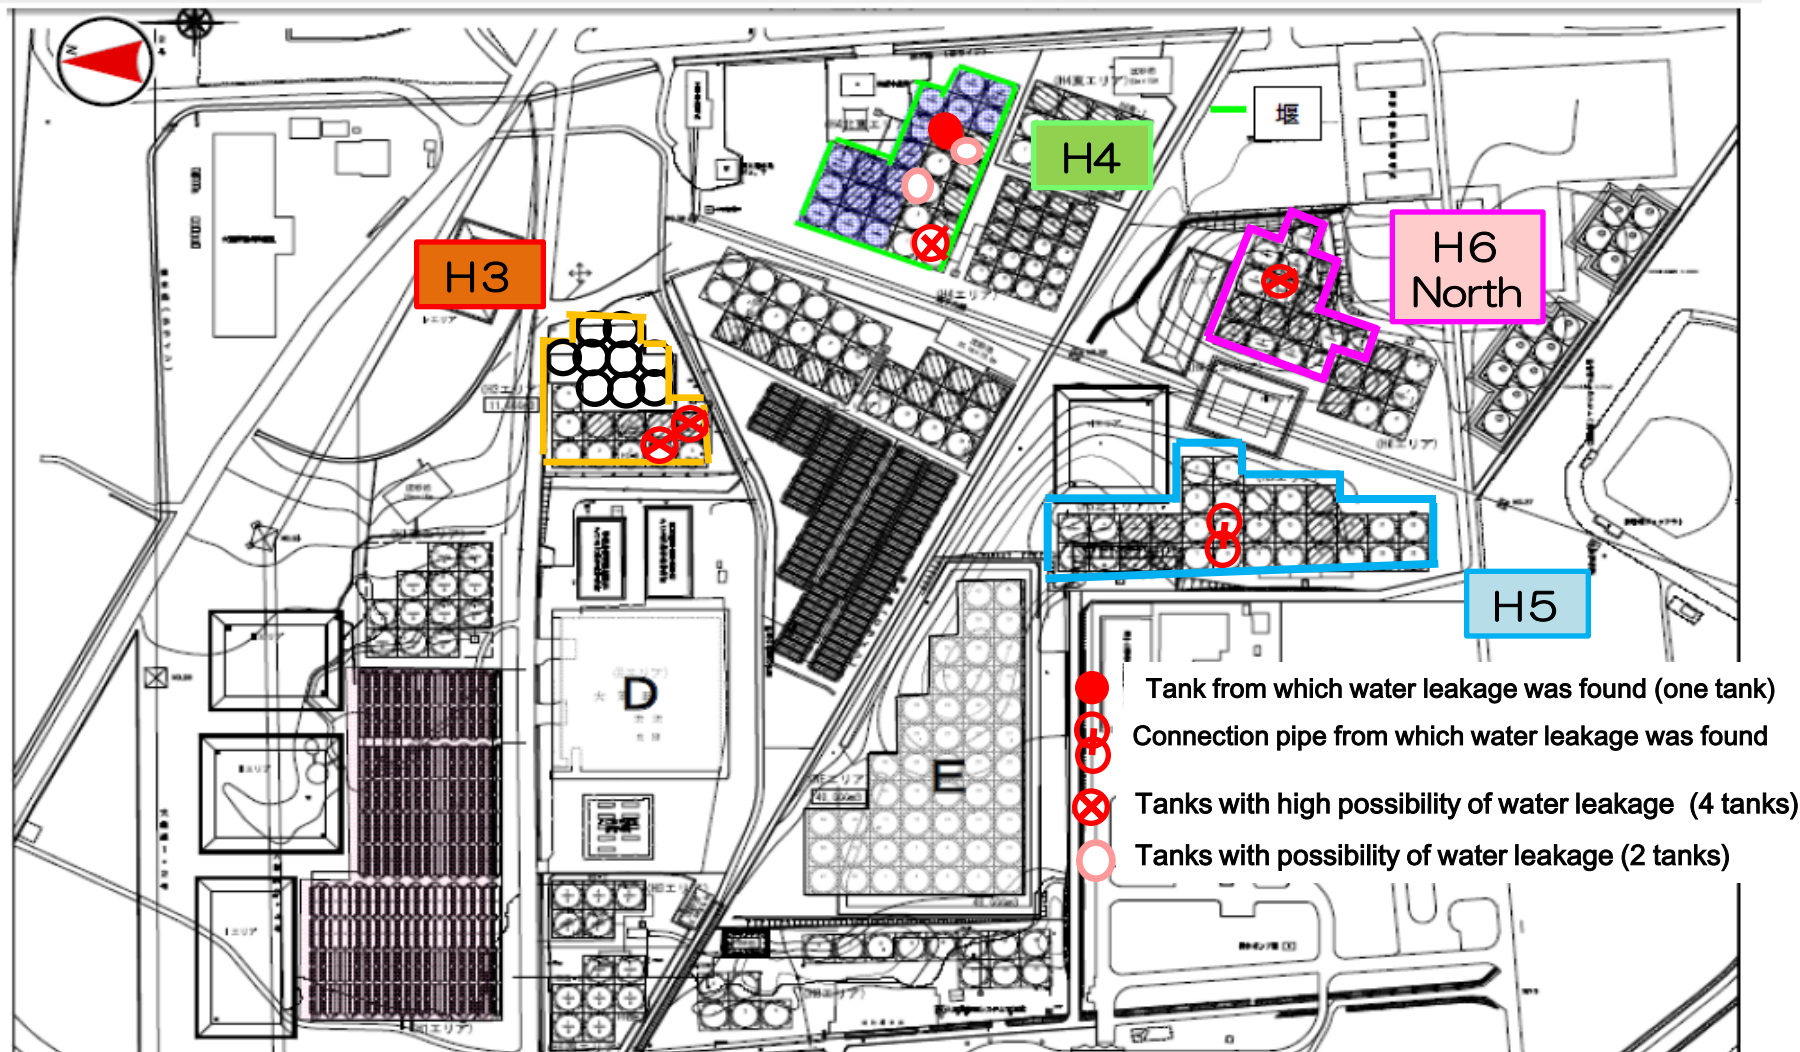
Location of Storage Tanks

There are 305 bolted-joint storage tanks for contaminated water at the Fukushima Daiichi Nuclear Power Station. According to the TEPCO's reports to the NRA, one of 305 bolted-joint storage tanks had an incident of water leakage, four storage tanks have the high possibility of water leakage, and one connection pipe between bolted-joint storage tanks had an incident of water leakage. [**Attachments 1 and 2**]

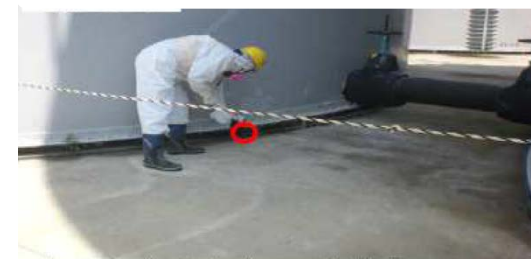
Tank B-No.4(South)

At the point 5cm from the flange, 1800 mSv/h * of β rays was detected by TEPCO on 31 August. No water leakage was found here.
